Thermawing Kit Modifications Amendment 1

This service bulletin (SB-06-002 Amendment 1) is being issued to upgrade the current Thermawing installations to the latest revision level. All effected parts should be replaced with the latest revision level parts included with this service bulletin. The parts installed prior to this service bulletin being issued will not affect the aircrafts safety or performance. The revisions are being issued strictly to increase the systems reliability.

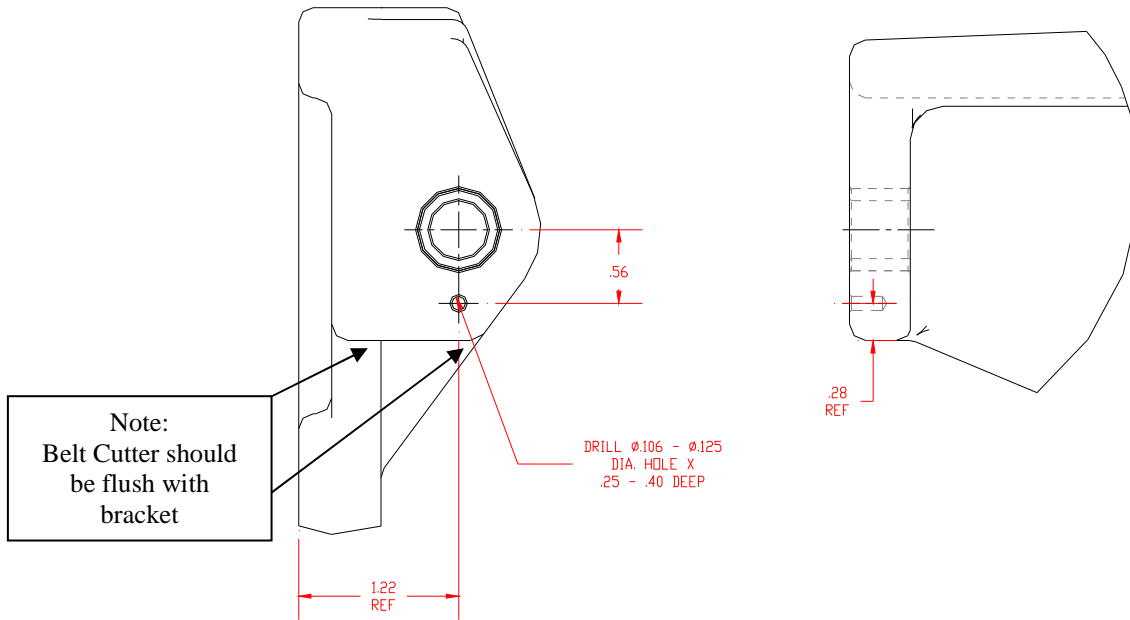
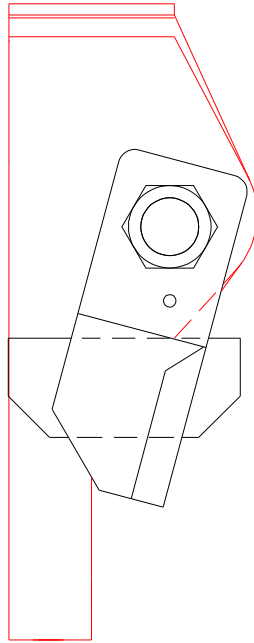
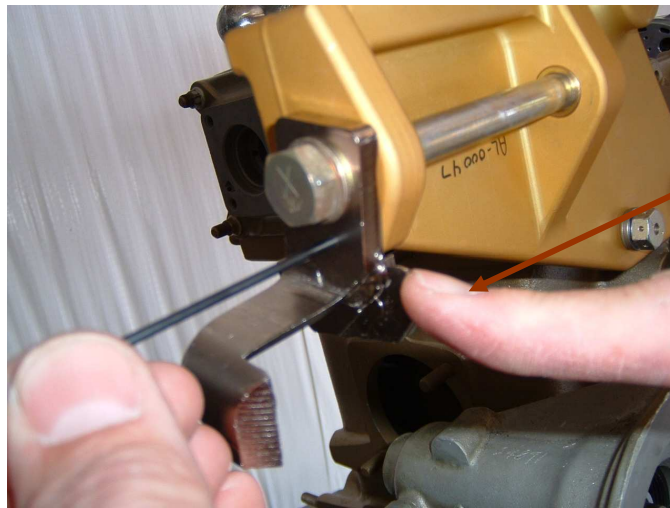
Figure 1

Red-Alternator Bracket

Black-Belt Cutter

NOTE-Position belt
cutter as shown.
Refer to drawing on
page 3.

Along with the service bulletin, Kelly Aerospace has provided a hole transfer punch, roll pin, and a belt cutter (AL-00025). Push the belt cutter against the bracket and place the hole punch through the hole drilled on the belt cutter as seen in figure 1.

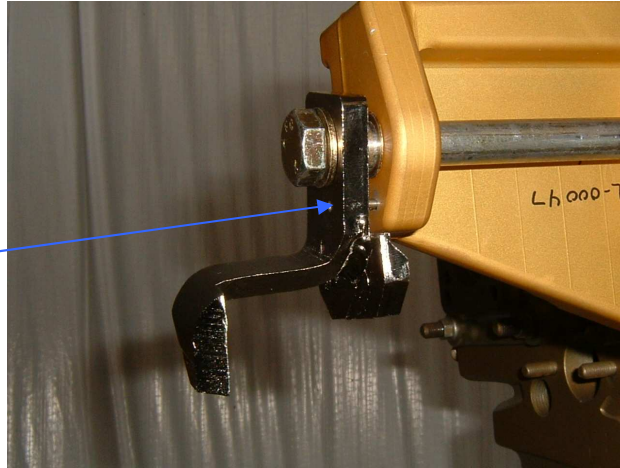
Figure 5

Notice the roll pin is flush with the surface of the belt cutter

Place the roll pin attached to the belt cutter into the alternator bracket (see figure 5).
