Lear Romec Fuel Pumps

Pressure to perform

AD2003-14-03 marks yet another effort by the Crane Manufacturing Corp. and the FAA to eliminate the persistent fuel leakage problem associated with the Lear Romec engine-driven fuel pump.

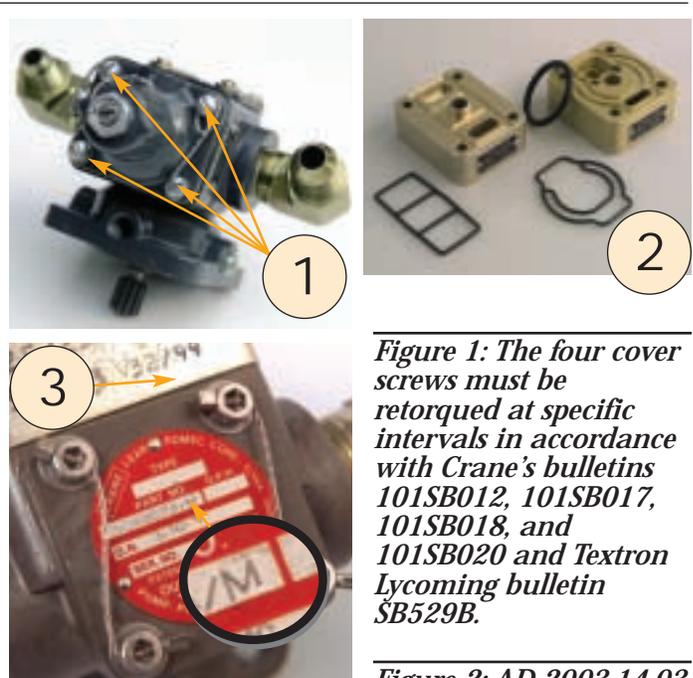
Mechanics have been faithfully performing repetitive torque check inspections on the four cover screws (see Figure 1 on page 11) on fuel pumps since 1976, when Lycoming first released SB406. Lycoming Service Bulletins

have repeatedly addressed the importance of inspecting Titan and Lear Romec model fuel pumps for potential leaks at the parting surfaces of the relief valve housing. Typically such leaks were symptomatic of gasket material that had taken a set or shrunk with time. This ongoing inspecting and retorquing the four cover screws at scheduled intervals was an attempt to eliminate fuel seepage.

Figure 1: The four cover screws must be retorqued at specific intervals in accordance with Crane's bulletins 101SB012, 101SB017, 101SB018, and 101SB020 and Textron Lycoming bulletin SB529B.

A second option that remains is to perform initial and follow-up torque checks. These recurring inspections must be performed within 10 hours time in service (TIS), or 30 days after the effective date (Aug. 14), whichever occurs first. Follow-up torque check inspections are to be performed every 50 hours thereafter. If the torque remains within the specifications found in

SB529B for an accumulated 100 hours, then a simple visual inspection is required at 50-hour intervals until the pump has been modified with Crane's kit. If the pump is simply overhauled or repaired, the entire sequence begins anew.
