Lear Romec Fuel Pumps

Pressure to perform

By Randy Knuteson

AD2003-14-03 marks yet another effort by the Crane Manufacturing Corp. and the FAA to eliminate the persistent fuel leakage problem associated with the Lear Romec engine-driven fuel pump.

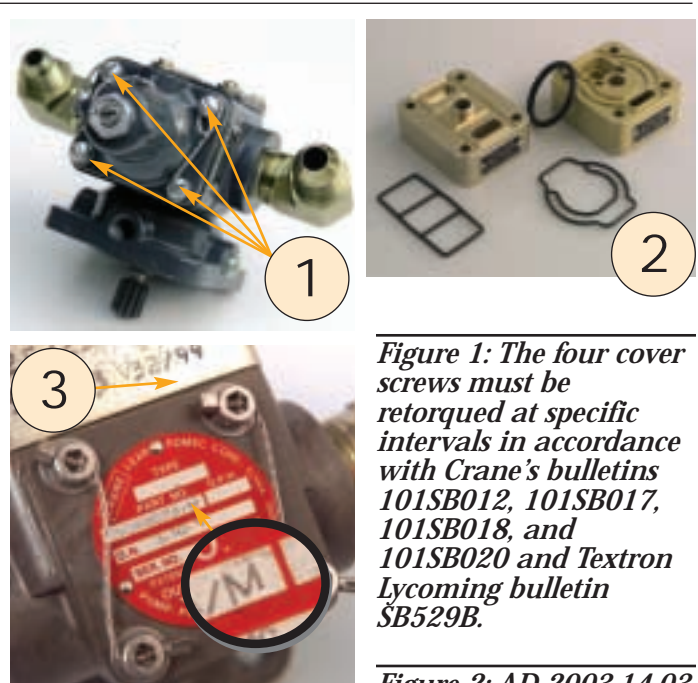
Mechanics have been faithfully performing repetitive torque check inspections on the four cover screws (see Figure 1 on page 11) on fuel pumps since 1976, when Lycoming first released SB406. Lycoming Service Bulletins

have repeatedly addressed the importance of inspecting Titan and Lear Romec model fuel pumps for potential leaks at the parting surfaces of the relief valve housing. Typically such leaks were symptomatic of gasket material that had taken a set or shrunk with time. This ongoing inspecting and retorquing the four cover screws at scheduled intervals was an attempt to eliminate fuel seepage.

Figure 1: The four cover screws must be retorqued at specific intervals in accordance with Crane's bulletins 101SB012, 101SB017, 101SB018, and 101SB020 and Textron Lycoming bulletin SB529B.

A second option that remains is to perform initial and follow-up torque checks. These recurring inspections must be performed within 10 hours time in service (TIS), or 30 days after the effective date (Aug. 14), whichever occurs first. Follow-up torque check inspections are to be performed every 50 hours thereafter. If the torque remains within the specifications found in

SB529B for an accumulated 100 hours, then a simple visual inspection is required at 50-hour intervals until the pump has been modified with Crane's kit. If the pump is simply overhauled or repaired, the entire sequence begins anew.
