Lear Romec Fuel Pumps

*Rock solid simplicity
(with a few rough edges)*

By Randy Knuteson

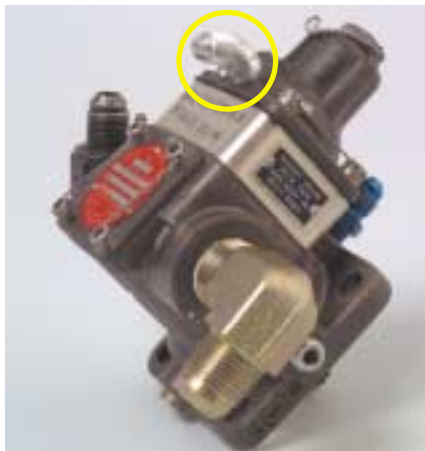
Textron Lycoming and Crane have issued numerous bulletins emphasizing the importance using orificed reference fittings. The type of fitting and orientation are determined by engine and airframe application. Orificed fittings are readily identified by an "R" stamped on the fitting. Lycoming Service Bulletins 487, 494, and 497 specify which fittings to use.

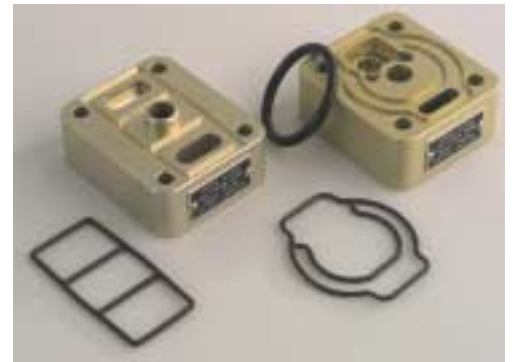
Pumps incorporating new valve housings manufactured by Crane/Romec are no longer subject to Lycoming SB 529. These relief valve housings rely on the improved sealing characteristics to eliminate fuel leakage and the need for repetitive torquing.

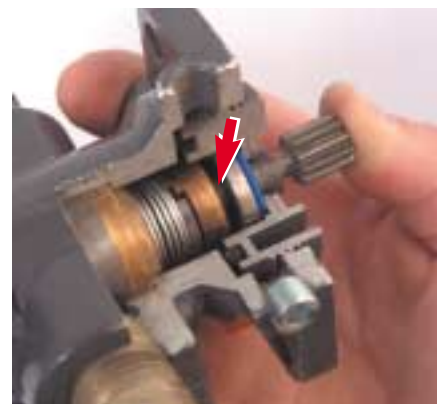
Do not depress the drive-coupling when handling or installing Lear Romec pumps. Depressing the coupling could allow contaminants to get between the disc and plate seal damaging the seal faces, and ultimately resulting in fuel leakage from the fitting at the base of the pump.

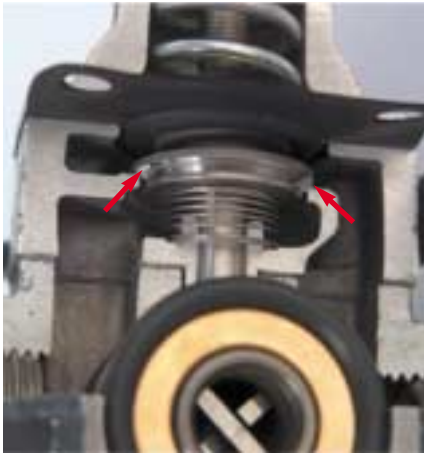
Contaminants trapped between the valve face and seating area can dramatically reduce pump output. Loss of pressure is more pronounced at idle speeds.
