Service Information Letter

Bulletin No. A-111

RECOMMENDED SERVICE/INSPECTION FOR CESSNA 402C EXHAUST BY-PASS VALVE ASSEMBLY

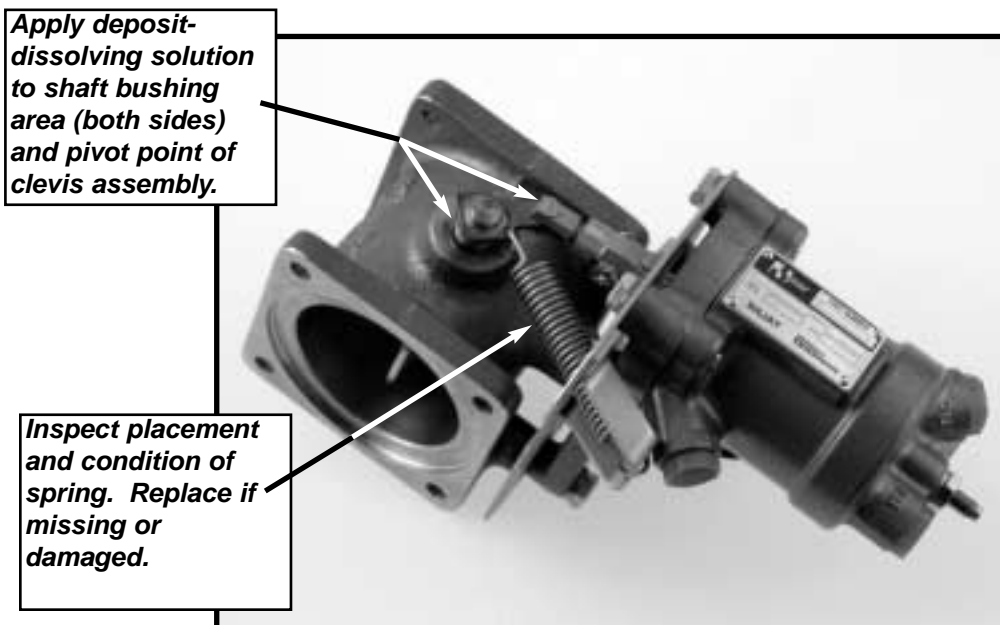
KAPS, Inc has become aware that under certain conditions it is possible for the wastegate butterfly valve to bind in the housing due to reduced endplay clearances between the valve and the end bearings. This phenomenon sporadically occurs after numerous short low altitude flights and is due to a resultant accumulation of lead deposits between the valve plate and bushings and/or the shim washers and bushing. A reduction in takeoff power or a problem with the Manifold Pressures sticking between 26 and 29 Hg could occur if this condition is left unattended.

Exhaust By-Pass Valve shown is for reference only.

- a. Remove engine cowling or reference panels to gain access to the Exhaust By-Pass Valve Assembly.
- b. Apply Mousemilk or Aero Kroil to the bearing surfaces and clevis pivot points during the inspection process. Application of either solution will encourage the removal of unwanted deposits. Lead deposits and carbonized oil (coking) effectively decrease endplay and thereby inhibit the free and unimpeded movement of the wastegate.

- c. After allowing time for the substance to penetrate the surfaces, it is permissible to lightly strike the wastegate shaft with a non-metallic faced hammer or brass drift to release residual lead deposits that have accumulated between the shims, bushings, or valve.
