All Navajo Chieftain Aircraft with the New Kelly Aerospace 200F-5002 (62E23186), 200F-5003 (62E23188) and 200F-5004 (62E23187) Fuel Pump(s) installed. NOTE: This bulletin is applicable only to Chieftain\* (PA-31-350) Aircraft with pumps bearing the S/Ns found in Table 1 below. Pumps installed on aircraft other than the PA-31-350 are not subject to this bulletin regardless of S/N inclusion in Table 1 below.

Isolated reports of minor fuel weepage from the relief valve housing at the parting surface on certain Kelly Aerospace engine driven fuel pumps have come to our attention. This condition has been noticed at the upper end of fuel pressure on Piper Chieftain Aircraft that use Kelly Aerospace Power Systems pumps. The purpose of this service bulletin is to provide information to Piper Chieftain owners, operators, and maintenance personnel regarding the inspection and factory repair of the KAPS 200F Series fuel pumps.

200F-5002, 200F-5003 and 200F-5004 Fuel Pumps in service on Piper Chieftains\*.

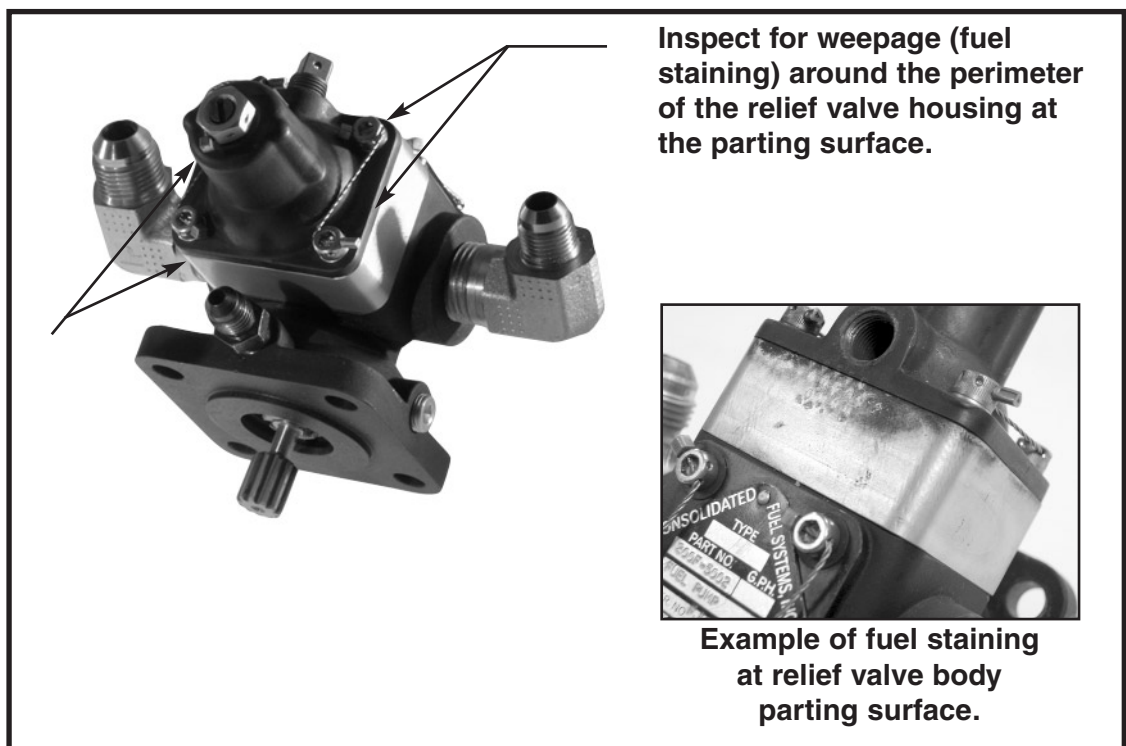
2. Visually inspect each fuel pump body for signs of fuel stains, giving careful attention to the relief valve cover parting surface (see Figure 1). Fuel weepage may appear as a greenish blue stain or darkened residue. Utilize supplemental lighting if needed to facilitate visual inspection. Visual inspection should include airframe areas around and beneath the fuel pump mounting locations.

**Figure 1: Inspect for weepage around the perimeter of the relief valve housing at the parting surface.**

3. If signs of fuel weepage are found complete the following steps:
  - a. Immediately remove fuel pump(s) from aircraft in accordance with the approved aircraft maintenance instructions.

- b. Contact Kelly Aerospace, Fuel System Service Department. Please use contact information below.
4. If no signs of fuel weepage are found around the parting surface of the fuel pump(s), the pump(s) may remain in service for an additional 25 hours or until the next scheduled Service Interval, at which time they must be removed and returned to the factory for repair.
