**REPLACEMENT BENDIX DRIVE SHAFT****INTRODUCTION:**

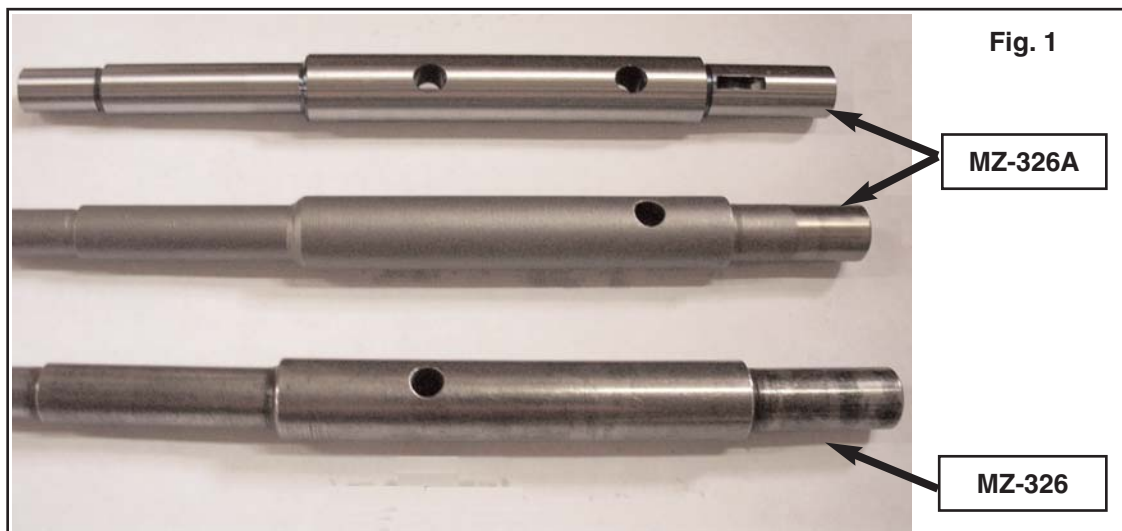
Kelly Aerospace Power Systems announces an alert regarding the Bendix drive shaft component part. Over the years, certain starter models have used a Bendix drive shaft made in two different manners. The original shaft had the pin hole at the bendix end of the shaft. Later starter models had the Bendix drive shaft pin hole located at the motor end of the shaft. In order to reduce cost and inventory requirements, a new shaft was developed and tested which has the pin hole located both at the bendix end and the motor end of the shaft. The current shaft P/N MZ-326A replaces MZ-326 and has been manufactured with both one pin and two pin hole configurations.

This Service Information letter is intended to alert the field that the P/N 326A Bendix drive shaft will be delivered only in a two hole configuration. All previous configurations of P/N MZ-326 or MZ-326A are now replaced.

For identification of the Bendix drive shaft, observe Figure 1 below.

At the discretion of the maintenance or overhaul facility any time the Bendix drive shaft part number MZ-326 or .MZ-326A is being replaced.
