Service Letter

Letter No. 026 A

NOTIFICATION OF PRECISION AIRMOTIVE LLC. MANDATORY SERVICE BULLETIN PRS-107 REV. 1 (FAA Emergency AD 2009-02-03)

SUBJECT: HEX PLUG 383493 COMING LOOSE FROM REGULATOR COVER

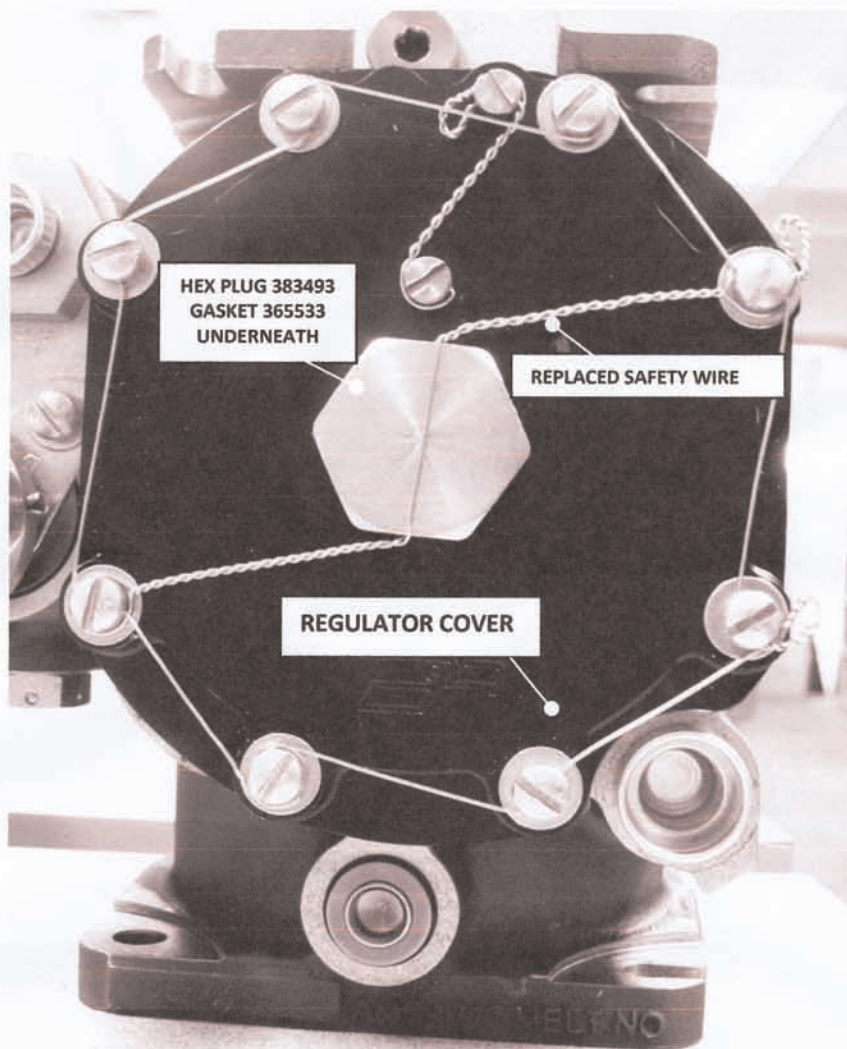
Note: Plug safety wire is wrapped around regulator screws under existing wire. It does not go through the holes in the screws.

7. The hex plug must be safety wired with .025 inch diameter wire to the regulator cover as shown in the figure below. The wire shall pass thru the plug such that it pulls the plug in the tightened direction and does not touch the corners of the hex on the plug.
