Service Letter

Letter No. 031

MA-4-5, MA-5 AND MA-6 SERIES ACCELERATOR PUMP LEVER ASSEMBLIES

Service Bulletin: SB-9
Revision: Original
Date: June 17th, 2009

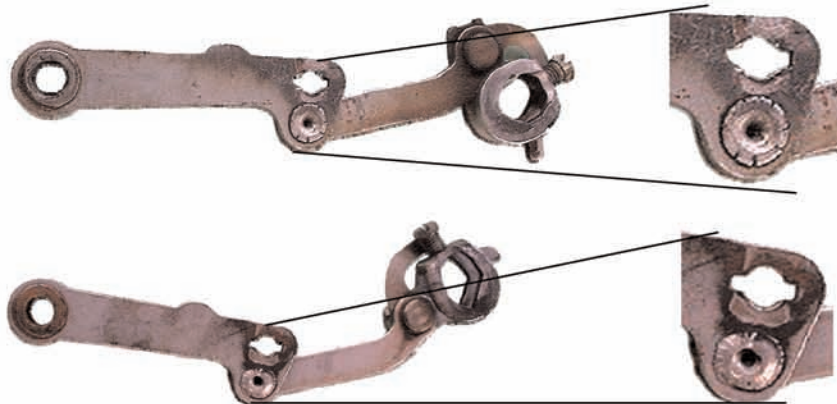
FIGURE 1 Suspect Parts

- a. A fragment (tag) of a cracked rivet could break off enter fuel passageways, and clog jets or fall into the accelerator pump chamber causing damage to the pump and body, see Fig. 1.

- b. A poorly formed or cracked fastener could fail, causing the linkage to become unfastened and possibly causing the throttle or mixture control to jam, see Fig. 1.

4. **Compliance:** WITHIN 100 HOURS OF OPERATION OR AT THE NEXT ANNUAL INSPECTION after the date of this Service Bulletin, which ever comes first, Volare recommends that levers having poorly formed and/or cracked fasteners (such as those shown in the accompanying photographs) be replaced.

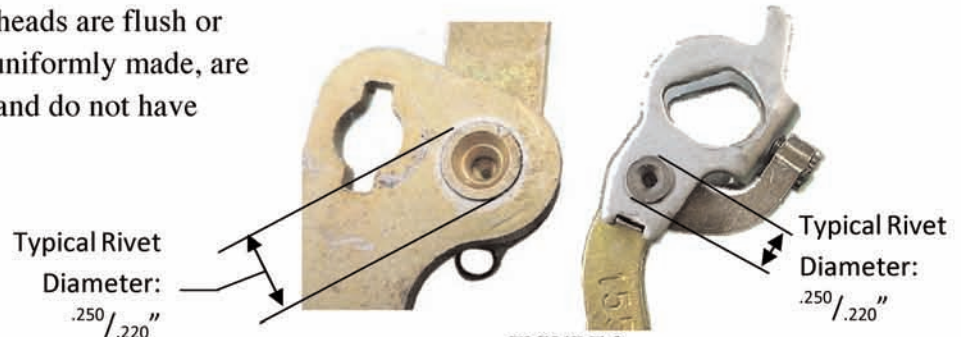
FIGURE 3

- ii. Volare fastener heads are flush or semi-flush, are uniformly made, are not overdriven, and do not have fractured tags.

6. **Instructions:** Examine the accelerator pump levers to determine that the fasteners are properly upset as shown in Fig. 3 and that the workmanship associated with them is of the highest quality. Replace any parts having overdriven or cracked fasteners with serviceable parts, see Figures 4 & 5.

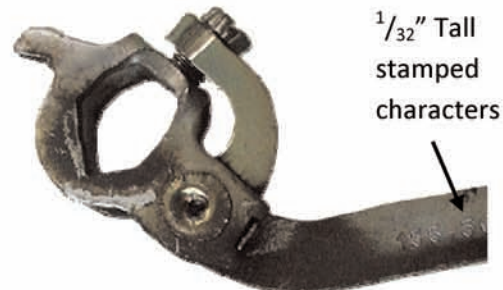
FIGURE 4

- i. Part number characters are 3/32" inches tall, and;

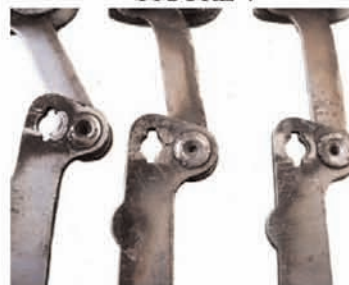
FIGURE 5

- ii. Fastener heads splay out over a large area, are not uniformly upset, are overdriven, often have multiple cracks, and may display fracture tags.
