USE OF UNAUTHORIZED THREAD SEALANT

Service Bulletin: SB-10

SUBJECT – UNAUTHORIZED THREAD SEALANT

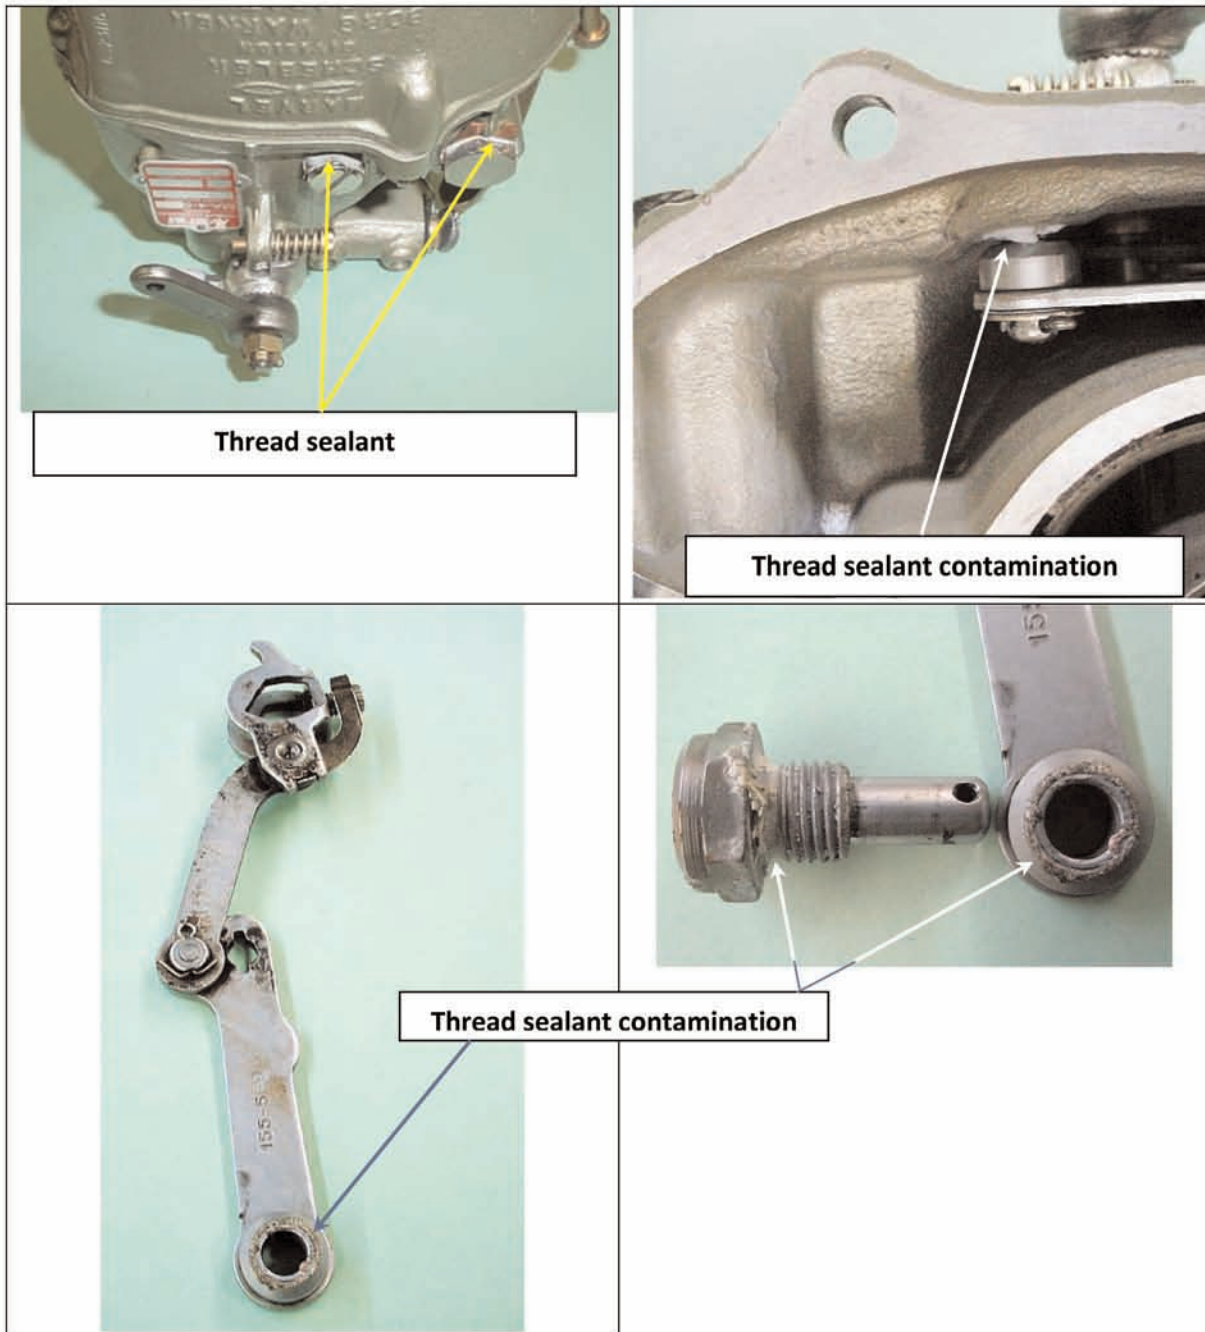
- a. Immediately inspect such carburetors for evidence of thread sealant around, but not limited to, various fittings particularly the inlet fittings, bowl drain plugs and, on MA-4-5 MA-5 and MA-6 series carburetors, the accelerator pump pivot screw. Thread sealant can often be seen as a whitish appearing hard or semi-hard paste extruding from under a fitting (see photos) but removal of the fittings may be required to conclusively exclude the presence of unauthorized sealant.

- b. If thread sealant is present, immediately remove the carburetor from service, disassemble it, remove the thread sealant, and inspect all passageways, jets, mechanisms, screens, etc., for contamination by the sealant. Using the appropriate service manual and all applicable Service Bulletins for the carburetor model being repaired, confirm that all techniques and materials for repairs to be accomplished are FAA and Volare approved. Clean, inspect, and reassemble the carburetor in accordance with the appropriate service manual.
