# Service Letter

Letter No. 033

## UNAPPROVED REPAIR PRACTICE (PEENING AROUND THE MIXTURE SHAFT BEARING BORE)

### Service Bulletin: SB-11

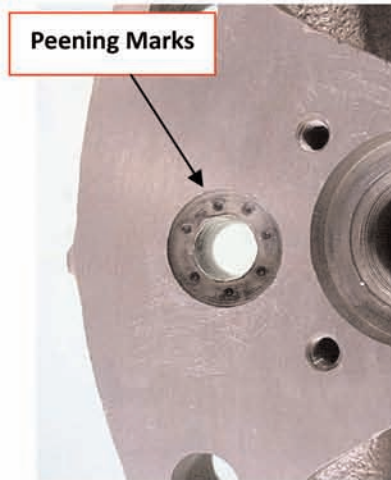
Fact: Peening the area around the bearing bore causes the mixture shaft loads to bear on small, upset metal projections which will wear away quickly. Thus, the repair will be short lived. Additionally, an airtight seal between the mixture control shaft and the throttle body is imperative. If the seal is compromised and outside (ambient) air enters the float bowl, an excessively rich fuel/air mixture will occur. The rough surface can prevent the necessary airtight seal.

Examples of unauthorized peening of the mixture shaft bore are shown in Figures 1 & 2 on page 2, (Fig. 1 bottom view, Fig. 2 top view). Figure 3 shows a properly repaired mixture shaft bore. The factory can make such repairs. If the mixture shaft bearing bore has inadequate metal remaining, contact Volare' to have the bore properly repaired.

Figure 1: Peened Example

4. **Compliance:** At the next carburetor disassembly or sooner if an excessively rich mixture is experienced:
  - a. Examine the mixture shaft bearing bore and area around it. If unauthorized repairs have been accomplished, the mixture shaft bearing bore is oversized, or the sealing surfaces are damaged, send the carburetor to Volare for repair.

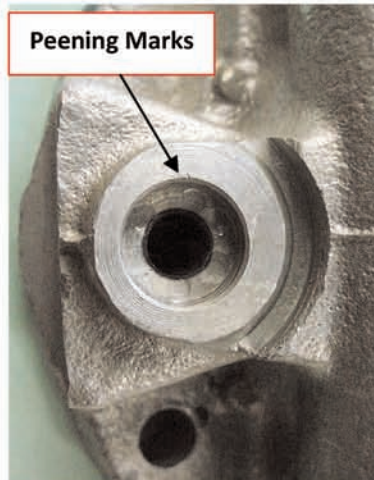
Figure 2: Peened Example

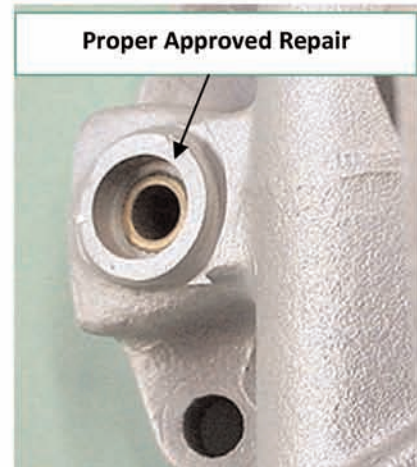
Figure 3: Proper Bushed Repair
