Service Letter

Letter No. 036

MIXTURE CONTROL STOP WEAR HA-6 TYPE CARBURETORS

Service Bulletin: SB-6

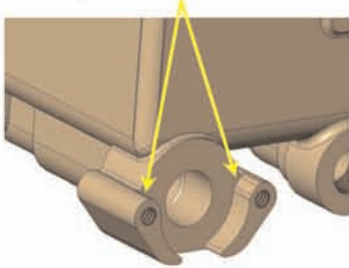
FIGURE 4

- c. Examine the mixture valve stops for wear in the areas shown in Figures 4 & 5. The maximum permissible wear depth is .046 inch.

Check for wear on BODY stops
EACH Side, not to exceed .046" deep

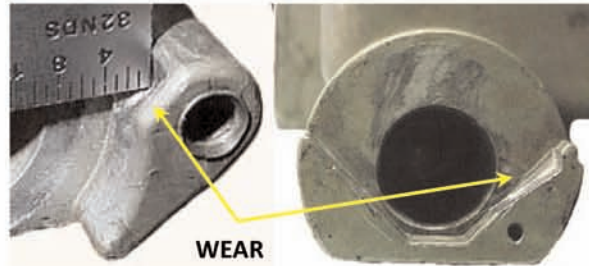
FIGURE 5

Current & earlier fuel mixture stop
designs showing excessive wear examples

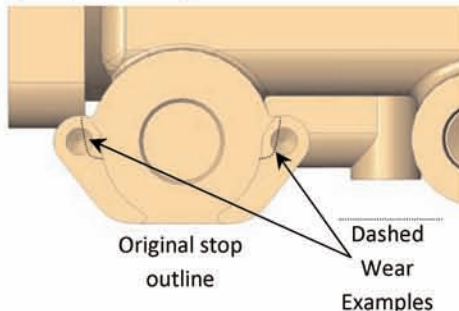
FIGURE 6

- e. Use a depth indicator, scale or other suitable measuring device to determine the depth of the wear, if any, of the stops. If the wear exceeds .046 inch below the 'original outline' of the part as shown in Figure 6, the carburetor must be submitted to Volare for repair, as in Figure 7.
