USE OF UNAUTHORIZED THREAD SEALANT

Service Bulletin: SB-10

SUBJECT – UNAUTHORIZED THREAD SEALANT

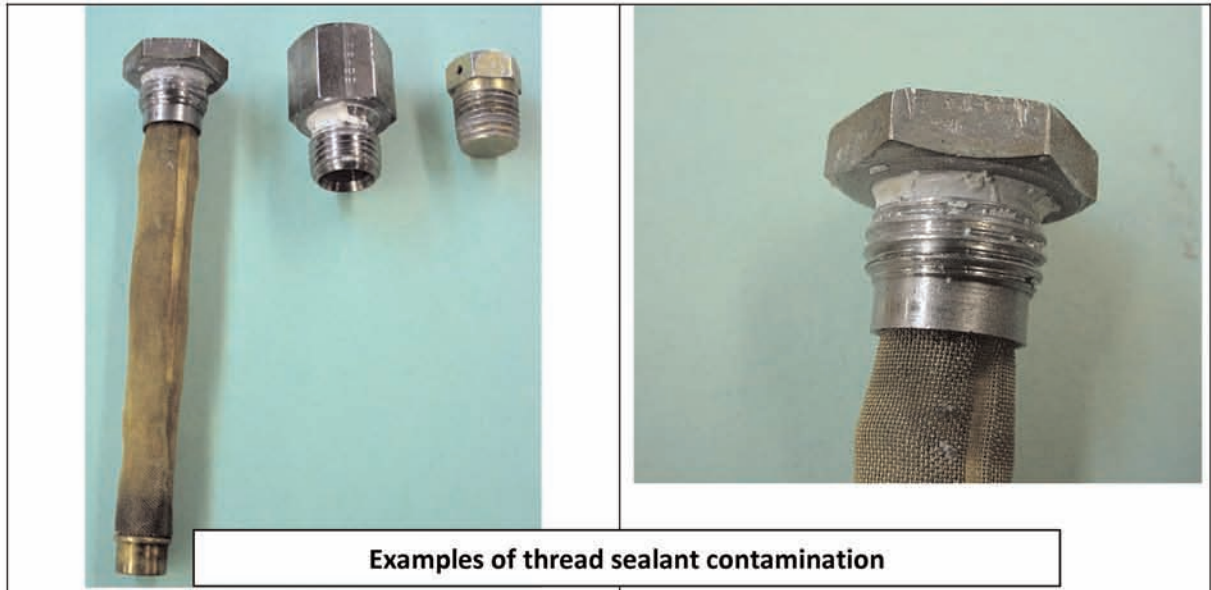
ATTACHMENT A (SL 032)

3. **Background:** During tear-down and inspection of Volare Float Carburetors at the factory service center, Volare has found thread sealant inside fuel passages. Volare's examination of carburetors identified with AVstar data tags reveals extensive use of thread sealant on various fittings and the presence of thread sealant inside carburetor fuel passages. Other facilities may also be following the similar unauthorized practice. **Volare does not use thread sealant on carburetors it manufactures or services and does not authorize or approve the use of thread sealant on its carburetors by others.**

- b. If thread sealant is present, immediately remove the carburetor from service, disassemble it, remove the thread sealant, and inspect all passageways, jets, mechanisms, screens, etc., for contamination by the sealant. Using the appropriate service manual and all applicable Service Bulletins for the carburetor model being repaired, confirm that all techniques and materials for repairs to be accomplished are FAA and Volare approved. Clean, inspect, and reassemble the carburetor in accordance with the appropriate service manual.
