Taking Charge of Alternator Problems

Single Engine Alternator Charging System Troubleshooting

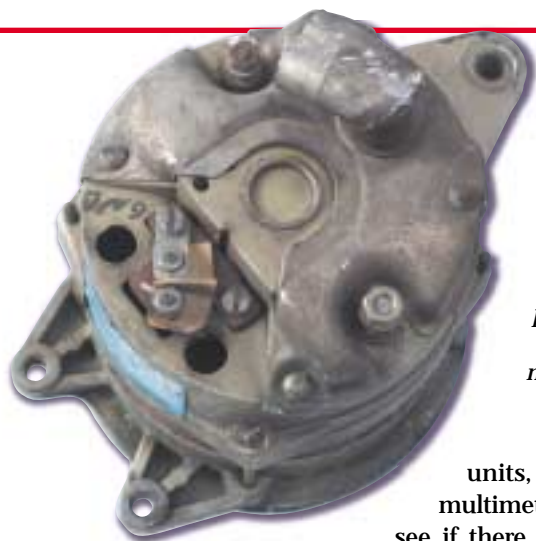
Figure 2: Example of a ground strap on the field for a Prestolite-style alternator. These can be easy to overlook, perhaps the reason a mechanic had marked this one.

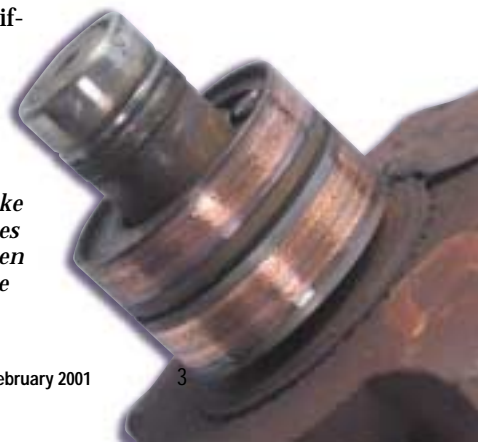
defective; (2) the alternator switch is defective; or (3) the over voltage sensor is bad. *Note: You could have any combination of the three.* At this point, check the input voltage of the circuit breaker and compare it with the output voltage. Again, if there is more than one-half volt difference, the circuit breaker must be replaced. Then perform the same input-voltage versus output-voltage test on the alternator switch. There cannot be more than one-half volt difference or the switch must be replaced. Voltage differences inside the switch or circuit breaker originate at the contacts. When they lose the dielectric

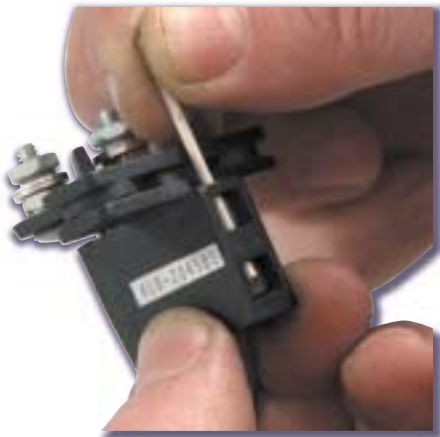
Figure 5: Insulated wire used as the brush retainer prior to re-installation of the brush block. Bare wire can scratch the slip ring when removed to release the brushes

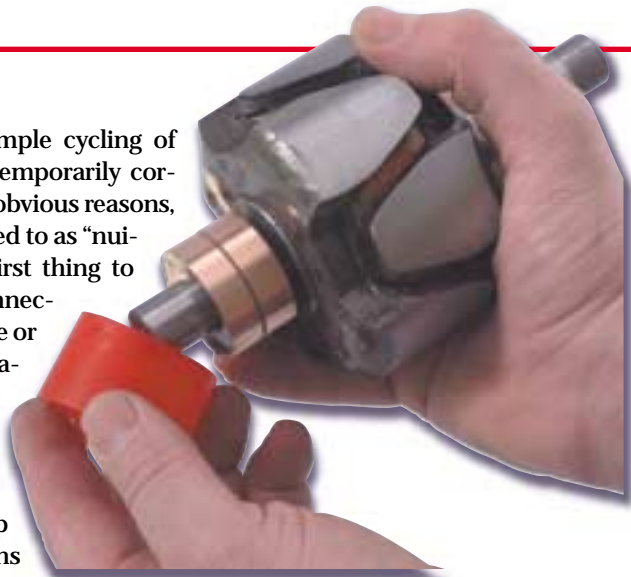
Figure 4: How your slip ring should look when you are ready to reinstall the rotor.
